SANITARY SURVEY REPORT

December 19, 2024 Julie Rhey-Baumann Clearwood 21603 North Clearlake Boulevard Southeast Yelm, Washington 98597	Clearwood ID #13615U	
	County:	Thurston
	System Type:	Community
	Operating Permit Color:	Green
	Surveyor:	Aasya Abdennour
	Water System Attendees:	Julie Rhey-Baumann Matthew Whitten Racheal Paige Sean Burns
	Inspection Date:	November 18, 2024

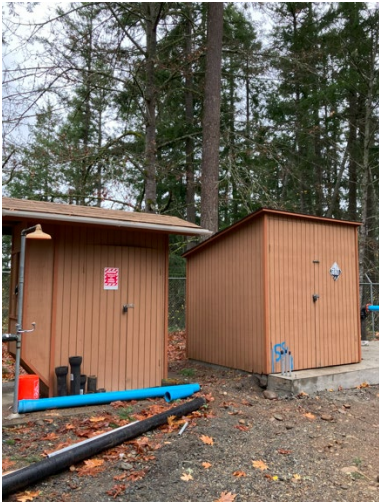
Clearwood’s water is supplied by two wellfields. Wellfield S03 includes Well #1 and Well #2. The site originally contained a pump house and a chemical shed for caustic soda but was under construction for system improvements. The site is fenced and locked.

S03 under construction

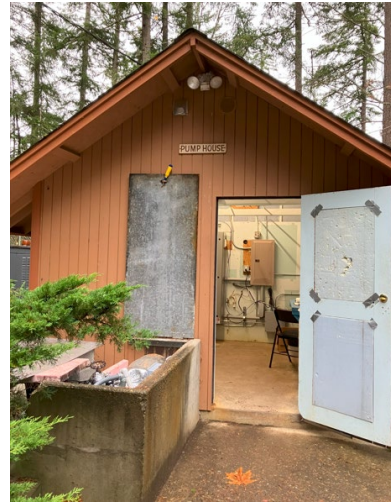
Well #1 is located outside the well house under a wood structure. At the time of the survey, Well #1 was disconnected. The caustic soda injection at this wellfield was taken offline in preparation for changing the piping configuration of the wellfield to accommodate for sodium hypochlorite injection. Well #2 is in a cement vault with a drain on the same site as Well #1.

Well #1 Pump House, disconnected

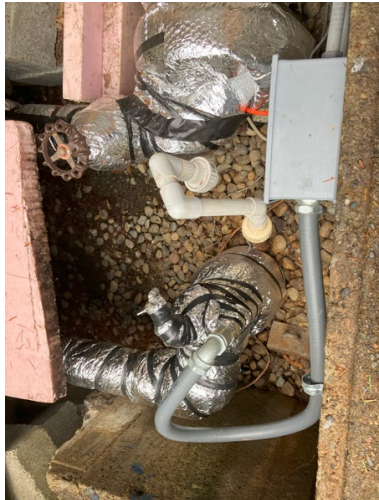
Well #1's vault, disconnected

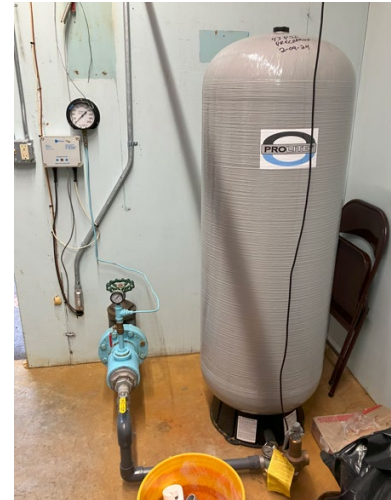
This system originally had three 150 gallon hydropneumatic tanks in the S03 Wellfield pump house. Those tanks have been replaced with a single 82 gallon bladder tank. This tank was not yet plumbed to the system.

Well #1 Pump House's new bladder tank,
disconnected

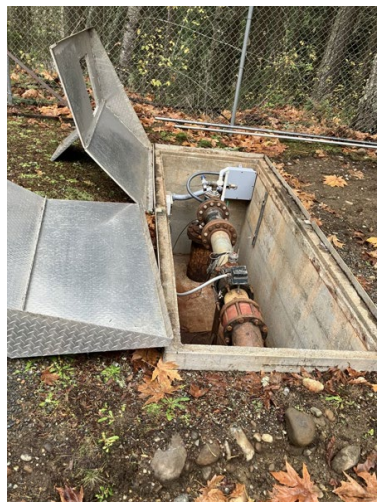
Well #2's vault

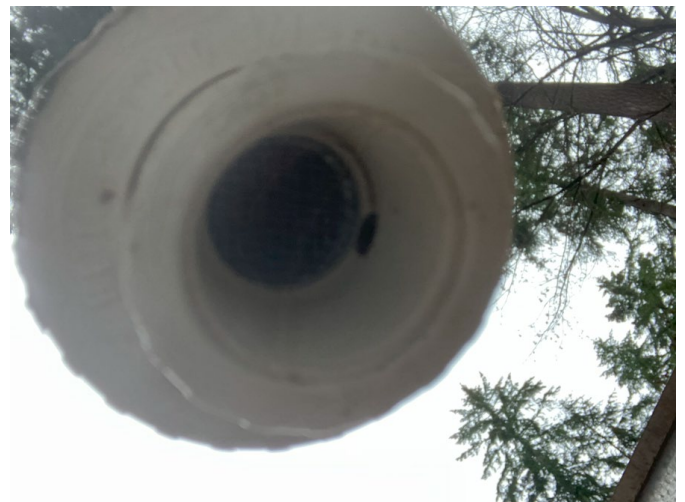
Well #2's vent screened

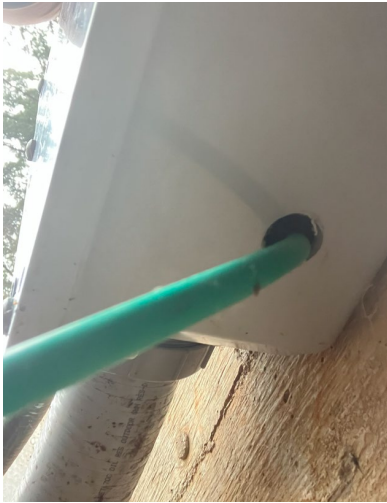
The electrical conduit from the well casing of Well #2 was not completely sealed at the underside of the junction box that allows possible contaminants to enter the system. This was sealed with National Sanitation Foundation (NSF) approved silicon at the survey.

Well #2's junction box not sealed at the conduit connection

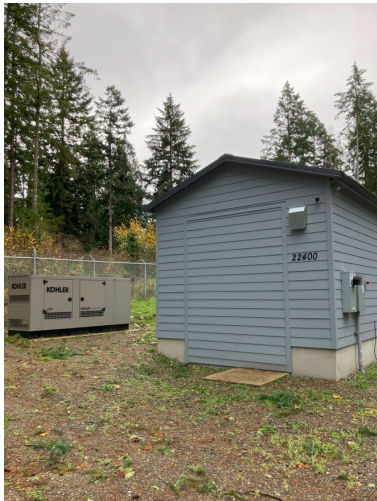
S08 treatment building

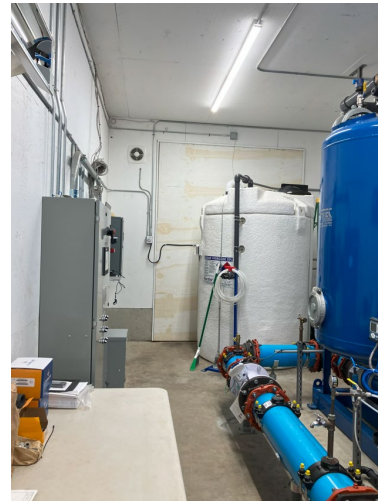
Caustic soda tank

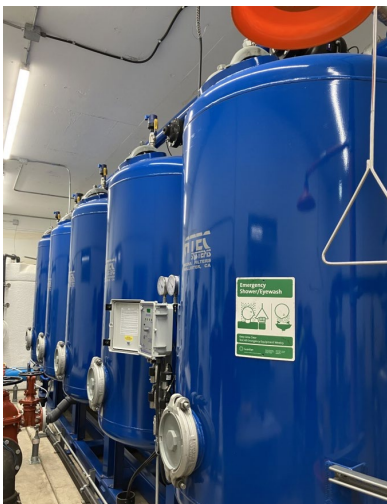
Clearwood has a HACH DR-900 to test for manganese and iron. The iron and manganese treatment filters are removing iron, but the system is still seeing manganese at the post treatment. It is suspected this is due to using air as an oxidant. The system plans to switch the air to sodium hypochlorite and install disinfection at both wellfields. This project is currently under review for approval with ODW.

ATEC filters

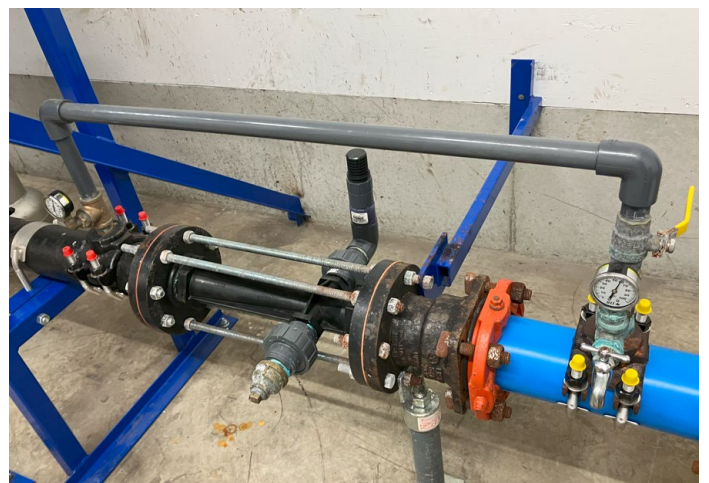
Aerator

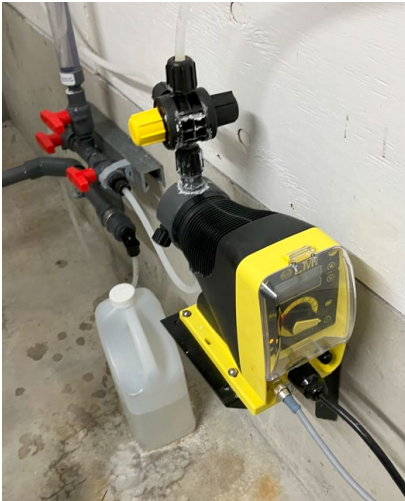
Caustic soda injection pump

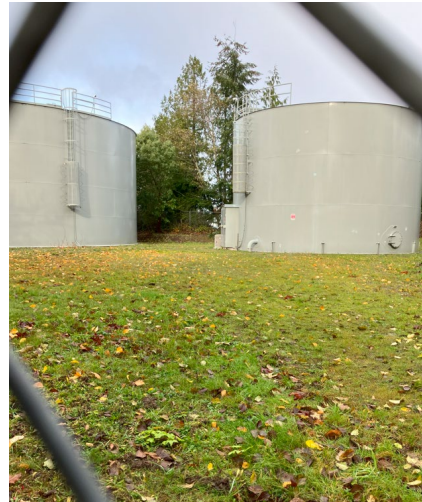
Reservoirs

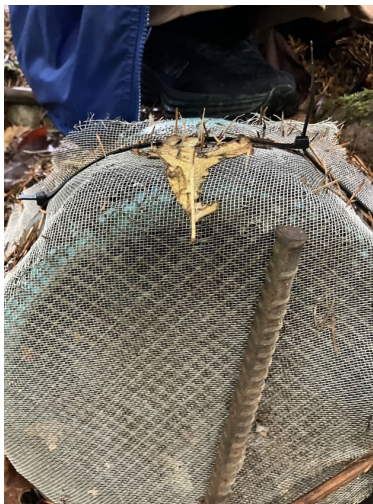
Reservoirs combined drain/overflow

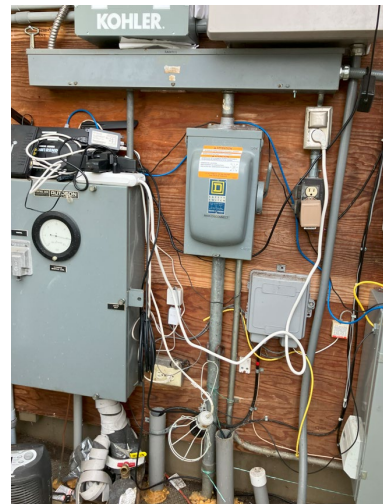
Reservoir controls

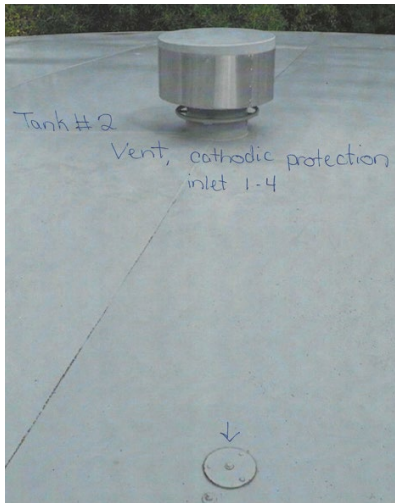
Reservoir #2 vent

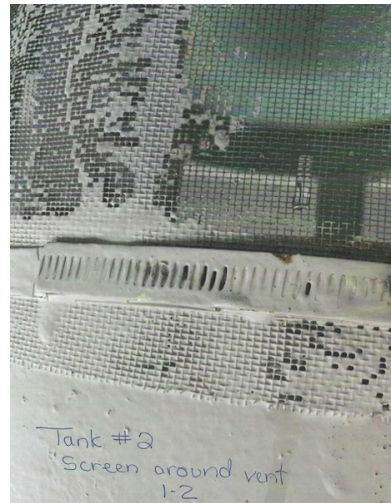
Reservoir #2 vent screened

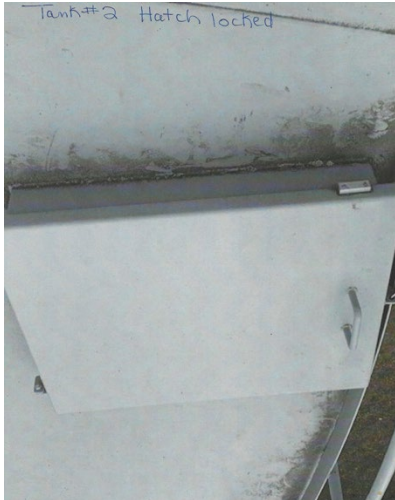
Reservoir #2 hatch locked

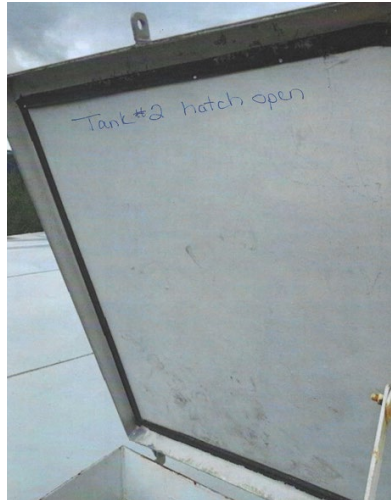
Reservoir #2 hatch seal

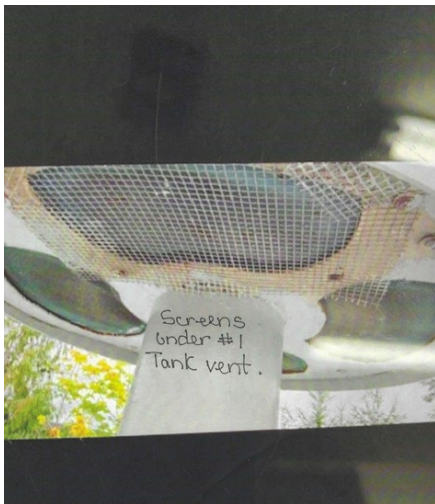
Reservoir #1 vent screens

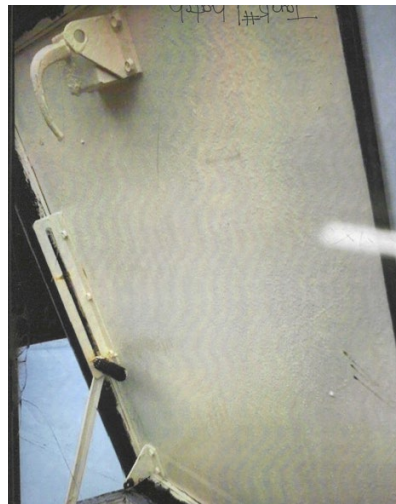
Reservoir #1 hatch seal

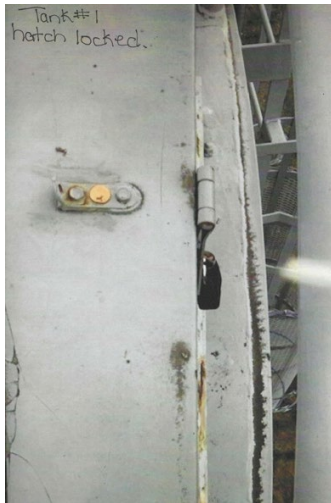
Reservoir #1 hatch lock

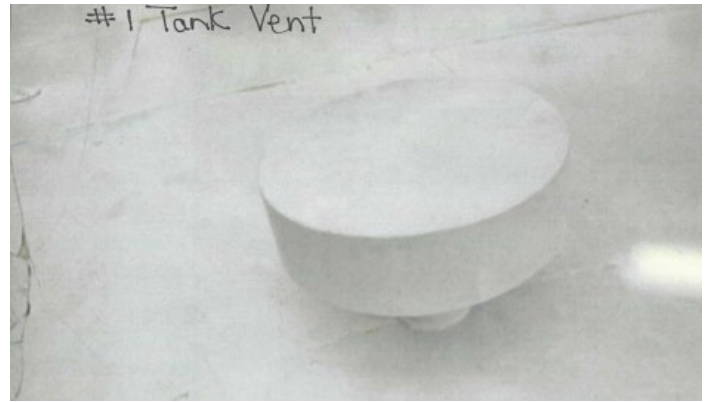
Reservoir #1 vent
